UNITED STATES ENVIRONMENTAL PROTECTION AGENCY

SUBJ: RCRA Compliance Evaluation Inspection  
BMW Manufacturing Corporation

## RCRA Inspection Report

BMW Manufacturing Corporation  
1400 Highway 101 South  
Greer, SC 29651

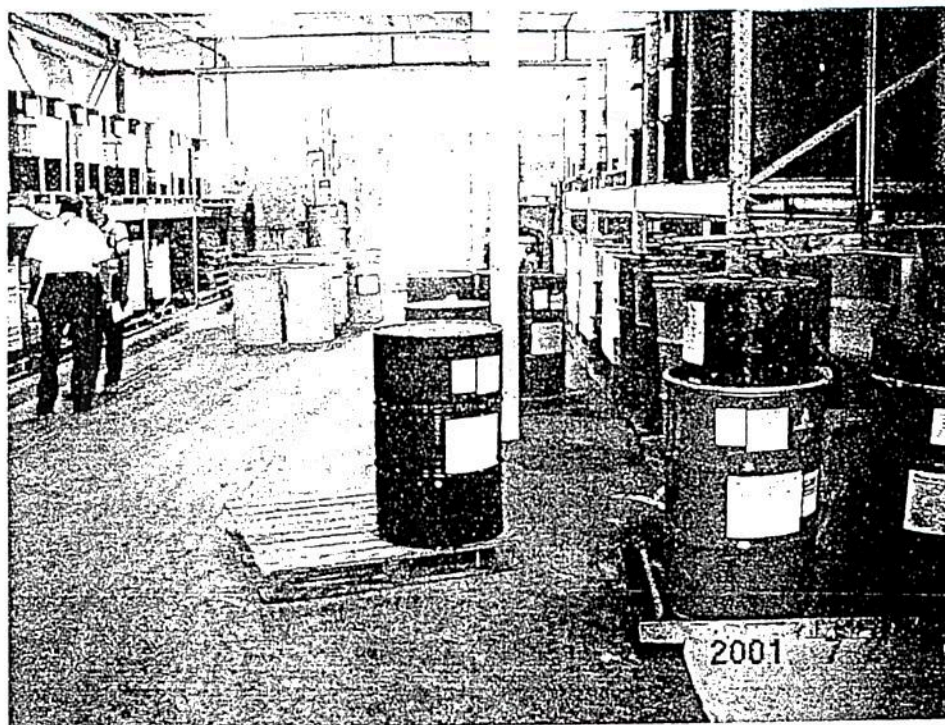
BMW uses a 90-day storage area for the storage of containerized hazardous waste, solid waste, used oil, and universal waste. BMW uses 550 gallon containers (totes) for the storage of hazardous waste purge solvent. The purge solvent is generated in the paint booths and piped to the mix room to a tank. From the tank, the waste purge solvent is pumped to a 550-gallon container located in the mix room. The container, once full, is then transferred to the hazardous waste storage area. At the time of the inspection, there were four 550-gallon containers of hazardous waste purge solvent stored in this area. All of these containers were properly closed, labeled, and dated (see photograph #1).

1. 90-Day Storage Area.

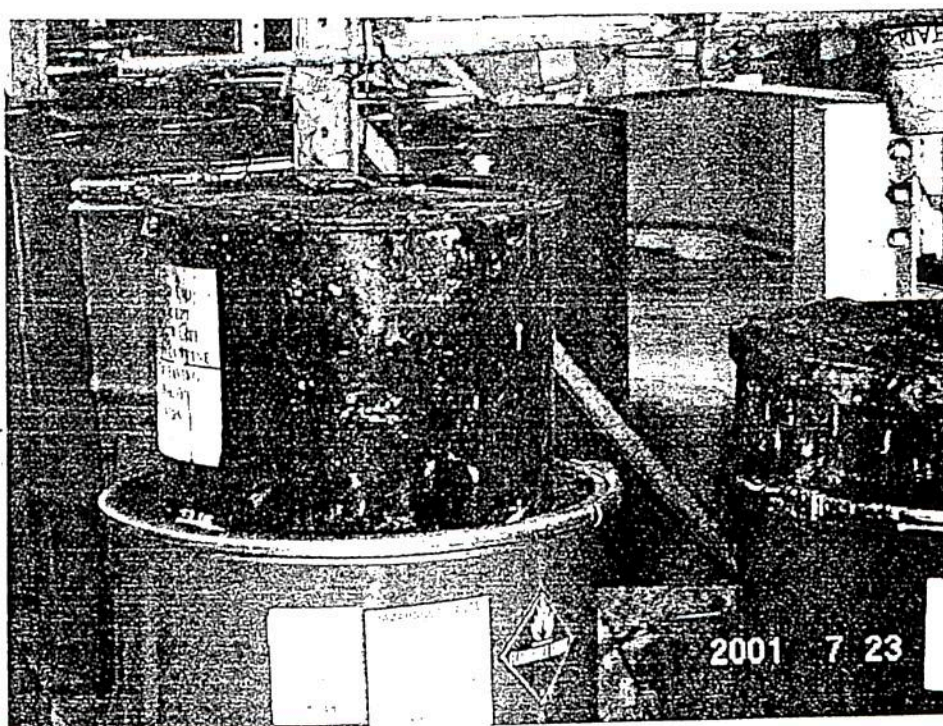
At the time of the inspection, a satellite accumulation container which is equipped with a closed draining device fitted to the top of a 55-gallon drum was located in this area. The draining device had either leaked or overflowed to the top of the drum (see photograph #2-3). There was hazardous waste present at the base of the device and on top of the drum. **BMW was operating this facility in violation of SCHWMMR R.61-79.262.34(a)(1)(i) and 40 C.F.R. § 262.34(a)(1)(i) for failing to containerize hazardous waste. This violation was corrected during the inspection.**

2. Satellite accumulation container located in the 90-Day Hazardous Waste Storage Area.

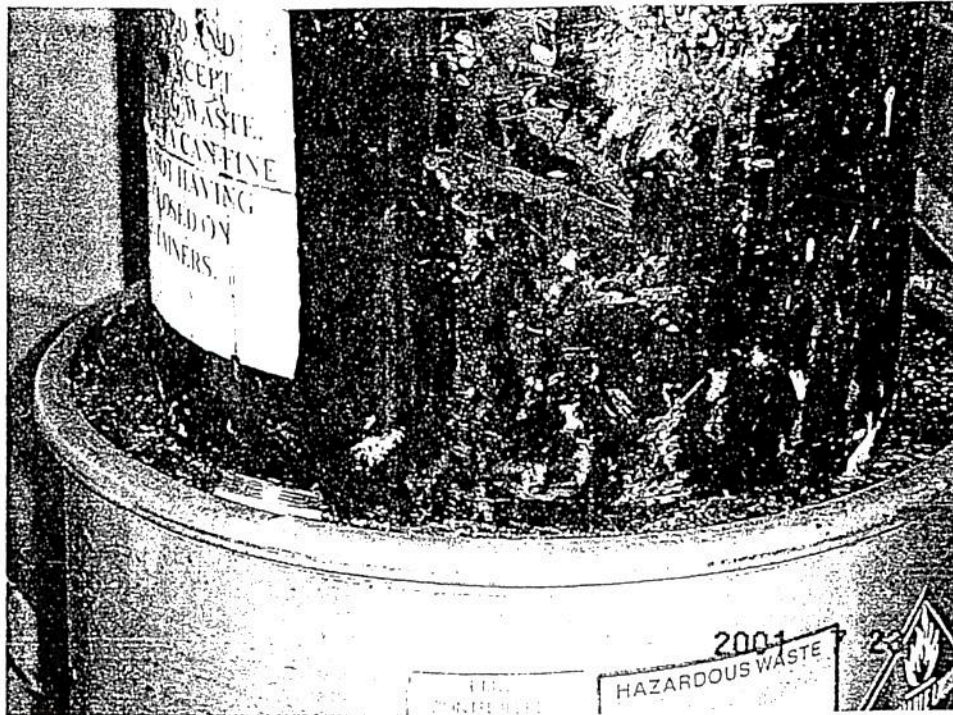
3. Detail of previous photograph.

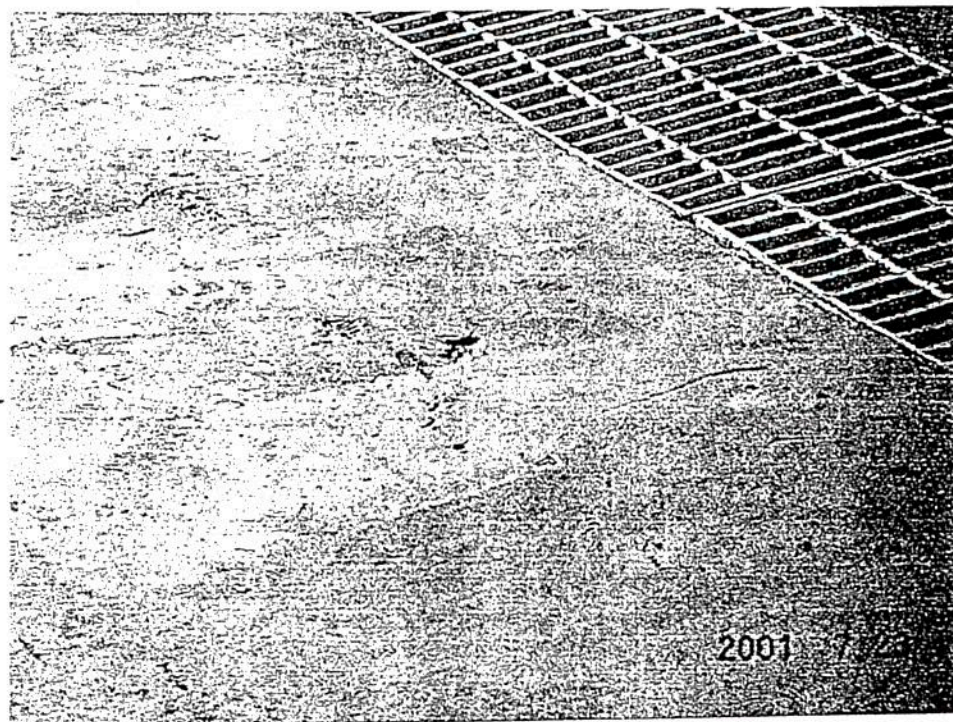
Totes and other containers of hazardous were being stored within the secondary containment area, as required by SCDHEC large quantity generator regulations. However, at the time of the inspection, there were two 55-gallon containers of hazardous waste which were being stored outside of the secondary containment area. These

containers were stored in an area where the floor was chipped and not properly sealed (see photograph #4). BMW must repair the floor and/or keep all containers within the secondary containment area with an adequately sealed floor pursuant to SCHWMR R.61-79.265.175(b)(1).

4. Damaged floor in the 90-Day Storage Area.

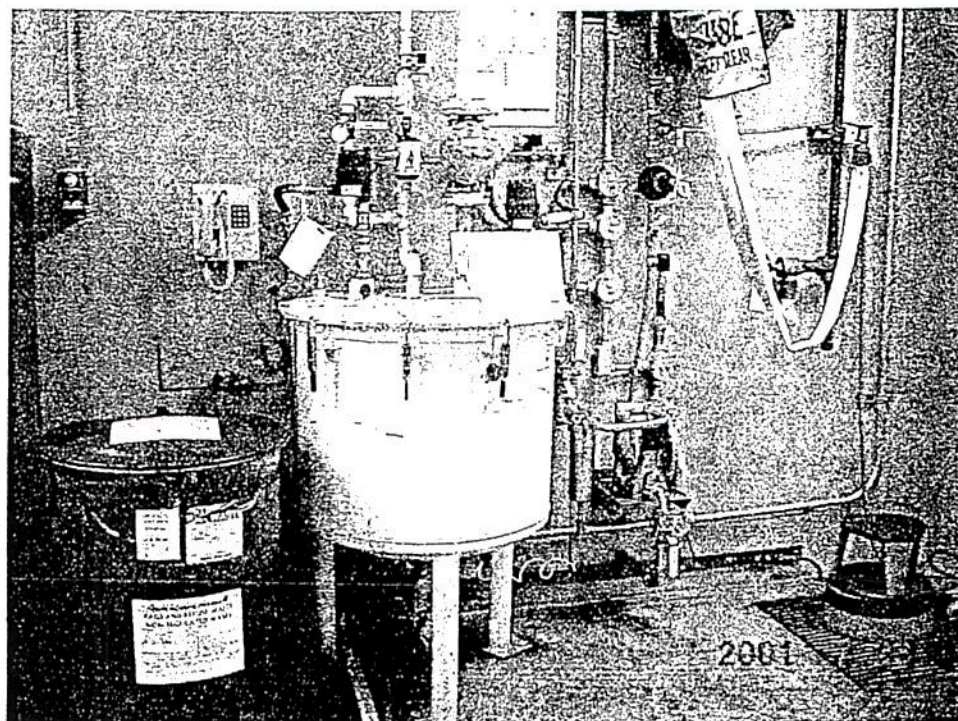
Hazardous waste purge solvent, generated in the paint booths is pumped from the recirculation tank (described later in this report) to an 80-gallon tank located in the paint mix room (see photograph #5). Once full, this tank pumps hazardous waste purge solvent to a 550-gallon tote located in the bulk storage room (see photograph #6-8).

Pursuant to SCHWMR R.61-79.265, Subpart CC and 40 C.F.R. Part 265, Subpart CC, BMW has vented this tank to a control device. The tank was inspected pursuant to SCHWMR R.61-79.265 Subpart J and 40 C.F.R. Part 265, Subpart J. No Subpart J and Subpart CC violations were noted at the time of the inspection.

5. Hazardous waste storage tank located in the Paint Mix Room.

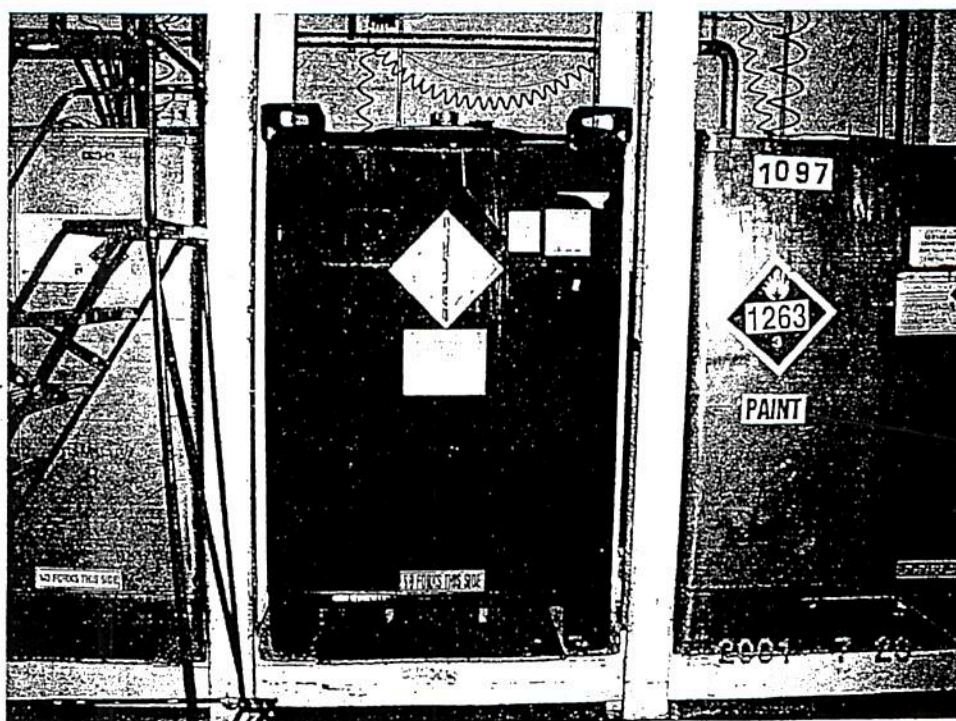
The hazardous waste storage tote was inspected pursuant to container management standards. The tote was properly closed, labeled, and dated. No RCRA deficiencies were noted with the tote at the time of the inspection.

6. Hazardous waste storage containers located in the Paint Mix Room.

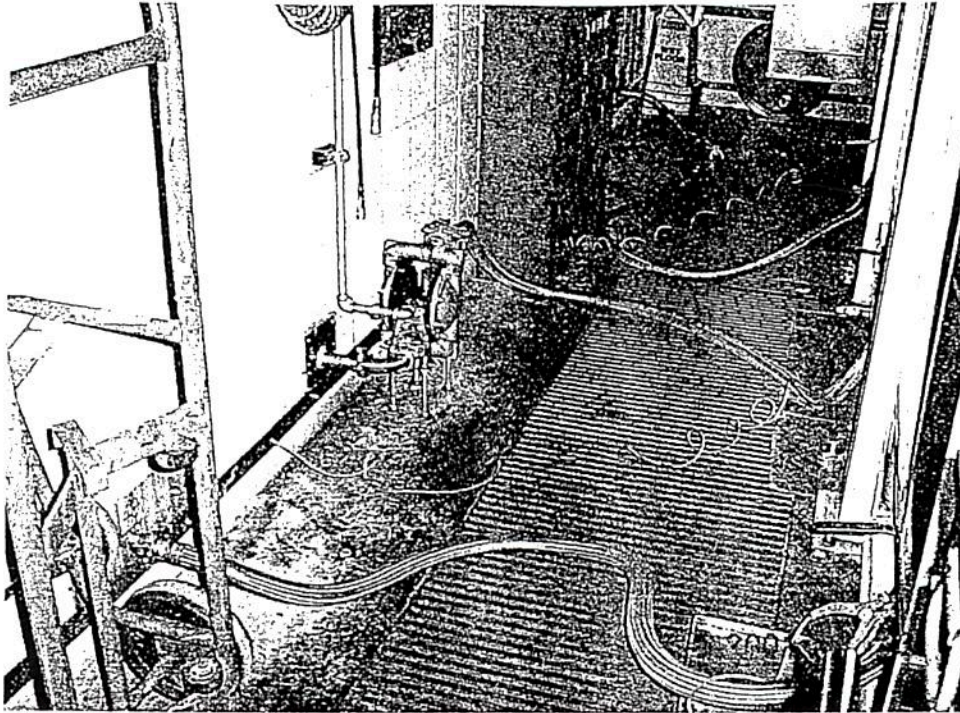
Noted at the time of the inspection was liquid in the sump located behind the hazardous waste storage tote (see photograph #7-8). BMW should make a hazardous waste determination for the material in the sumps and improve housekeeping in this area to assure that hazardous waste is not released to or stored in sumps. **BMW is in violation of SCHWMR R.61-79.262.11 and 40 C.F.R. § 262.11 for failing to make a hazardous waste determination for the waste in the sump behind the hazardous waste storage tote.**

7. Piping from the hazardous waste storage tank to the hazardous waste storage container (Paint Mix Room).

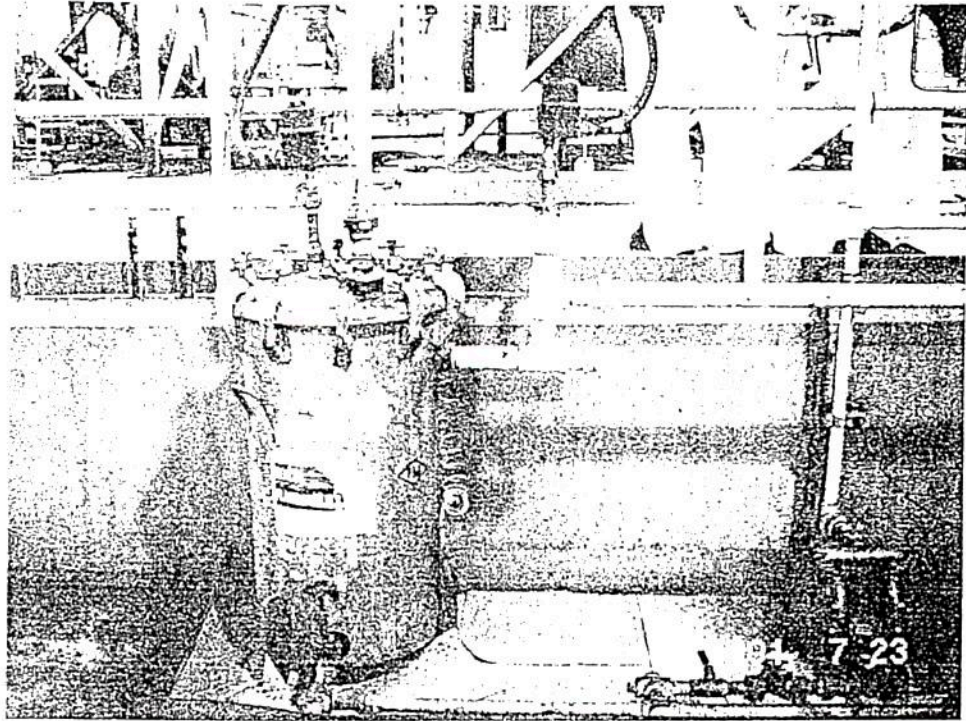
Located in the basement of the building is an 80-gallon recirculation tank (see photograph #9-14). This tank receives waste paint and purge solvent from the clear-coat paint line. Once the spent purge solvent enters this tank, it is pumped back to the gun boxes to maintain a constant flow of spent solvent within the purge collection system. The spent solvent entering the gun box does not contact the spray nozzle of the robot. Once the solvent level in the recirculation tank reaches a certain point, the solvent is directed from the tank to the hazardous waste tank located in the Paint Building.

9. Purge collection tank located in the basement.

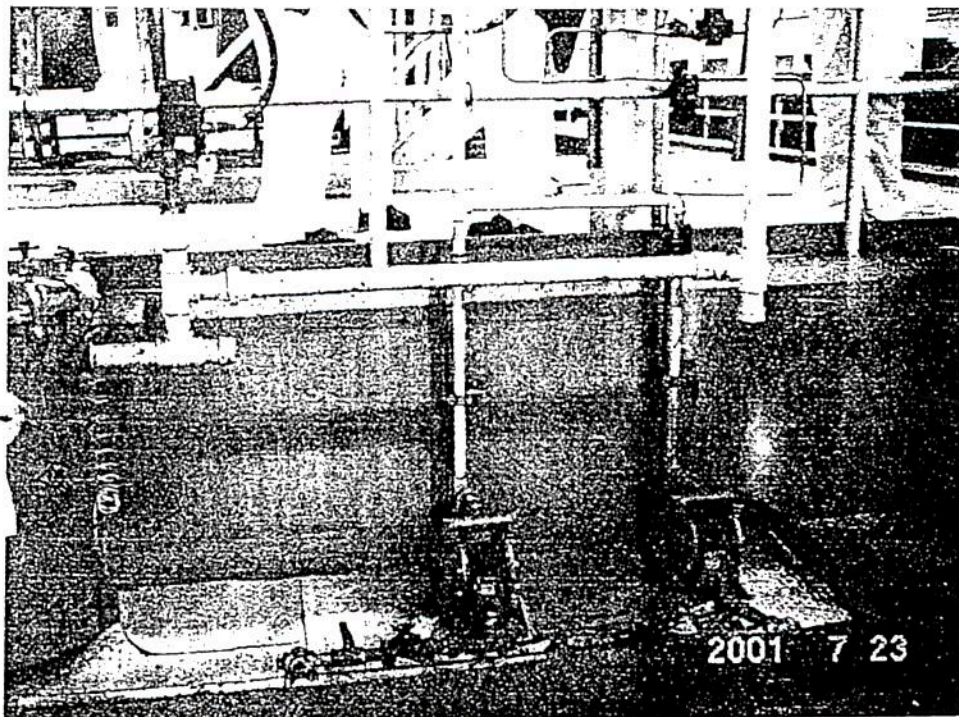
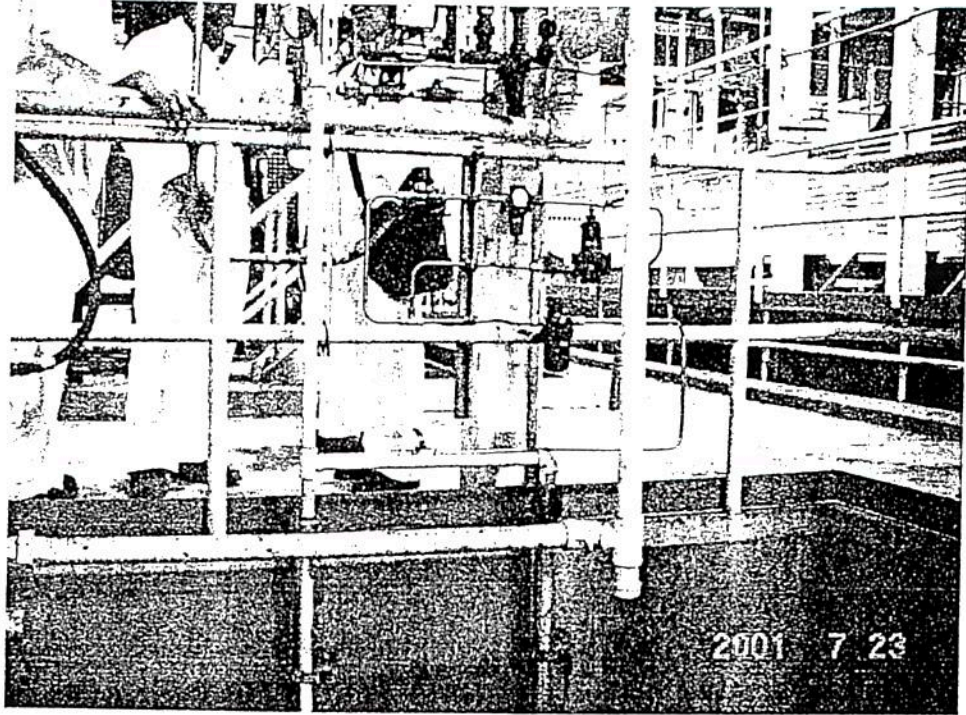
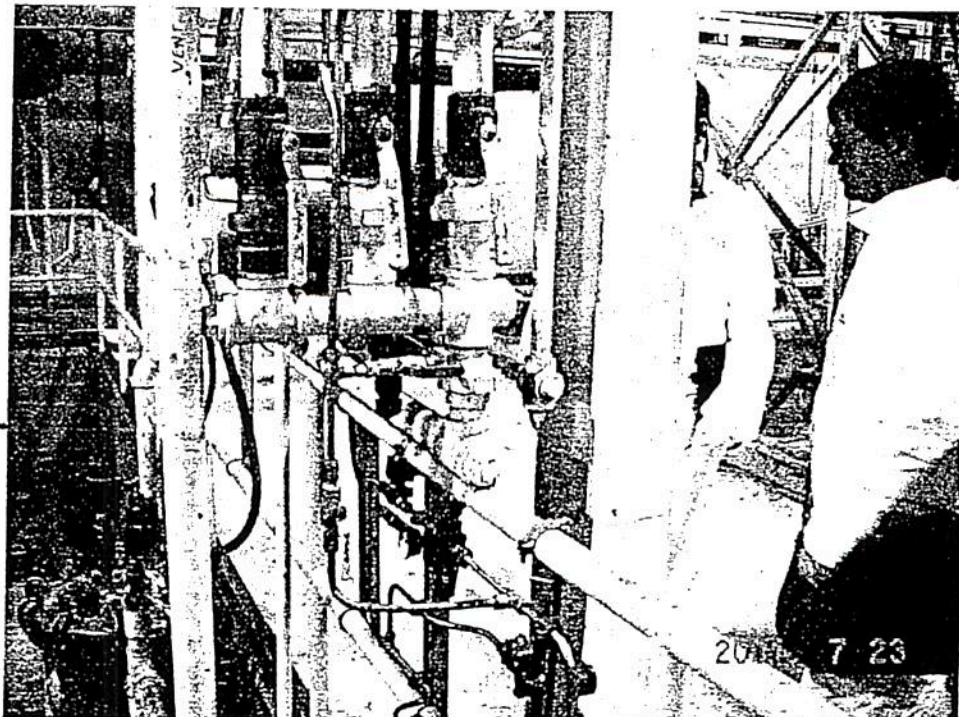
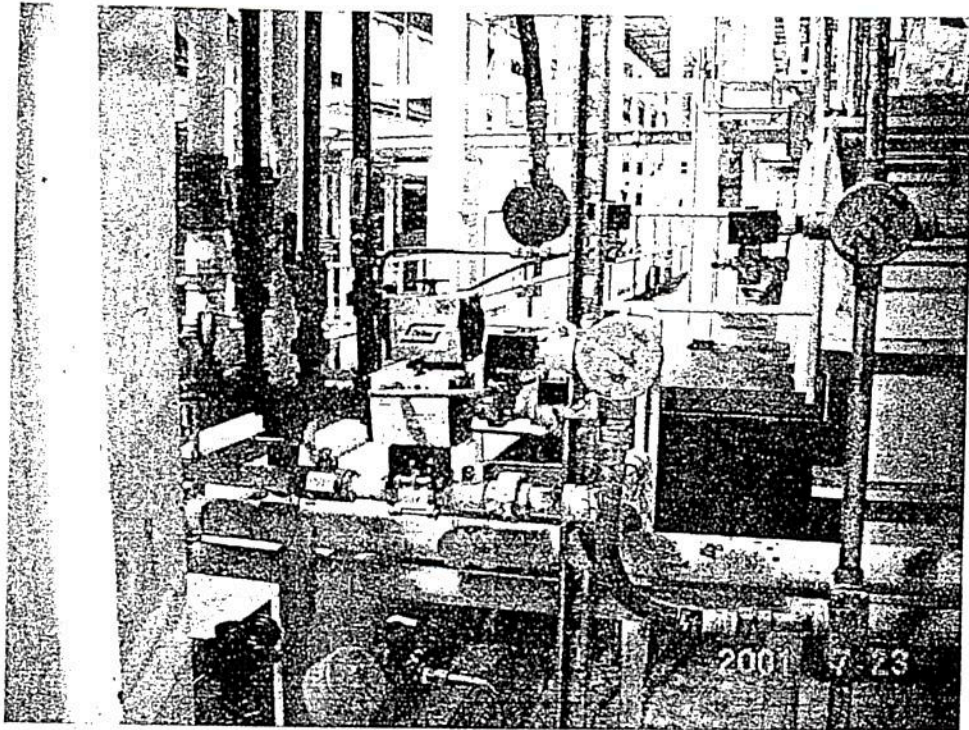
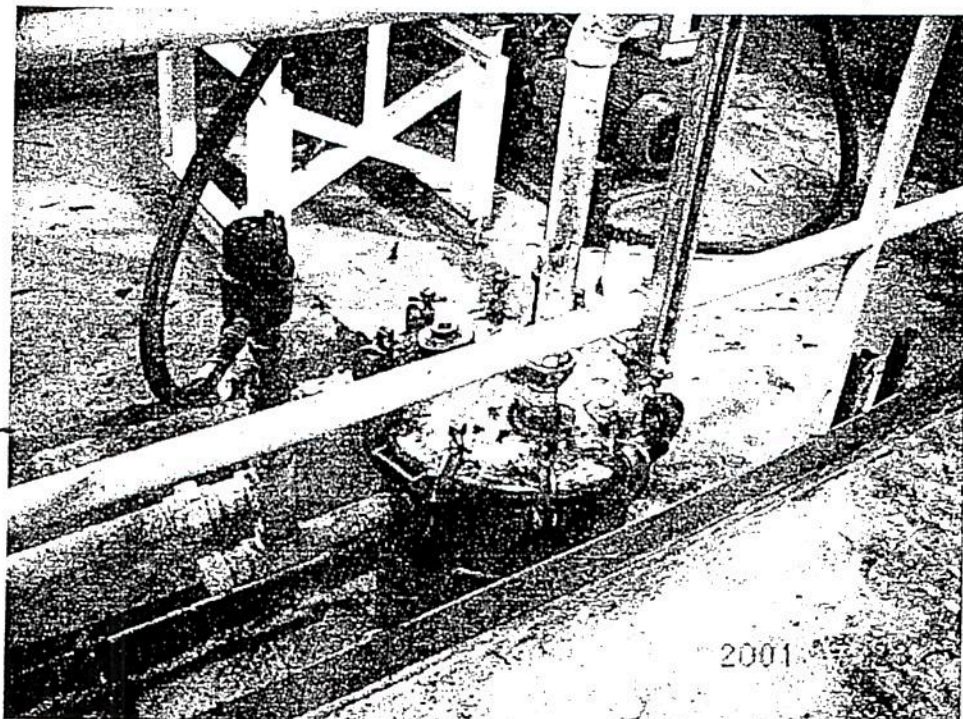
SCHWMR R.61-79.265.1050(c) and 40 C.F.R. § 265.1050(c) require that each piece of equipment to which this subpart applies shall be marked in such a manner that it can be distinguished readily from other pieces of equipment. BMW has not marked such equipment. BMW has failed to adhere to a condition for exemption from RCRA § 3005 given in SCHWMR R.61-79.265.1050(c) and 40 C.F.R. § 265.1050(c), as incorporated by SCHWMR R.61-79.262.34(a)(1)(ii) and 40 C.F.R. § 262.34(a)(1)(ii). As such, BMW is illegally storing hazardous waste.

Pursuant SCHWMR R.61-79.265.193 and 40 C.F.R. § 265.193, an owner or operator must provide secondary containment that meets the requirements of SCHWMR R.61-79.265.193 and 40 C.F.R. § 265.193 so as to prevent the release of hazardous waste or hazardous constituents to the environment. BMW has not demonstrated secondary containment for its hazardous waste purge piping system.

10. Purge collection system piping.
